TRI-STATE SMART HOME SOLUTIONS LLC

COMMERCIAL INSPECTION

1234 Main Street
Gallipolis, OH 45631

Buyer Name
07/15/2024 9:00AM

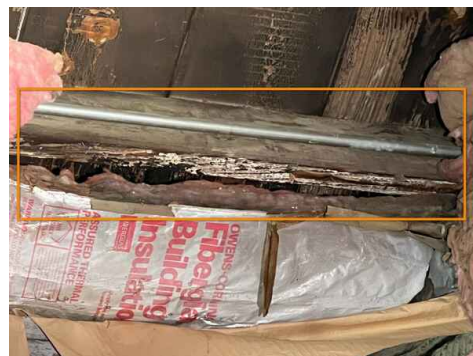
- There are active roof leaks in both the warehouse roof and the loading dock area roof.
- The warehouse roof seams and fasteners need to be resealed and re-coated, they are leaking.
- The flashing around the main power entrance cables needs to be replaced on the main warehouse roof.
- The loading dock area roof has visible holes in the roof and the roof metal is damaged in several areas.
- The wood framing, eaves, and soffit areas of both roofs are rotted and deteriorated in some areas.

Main Warehouse Roof, Interior Example of Rood Framing Wood Rot

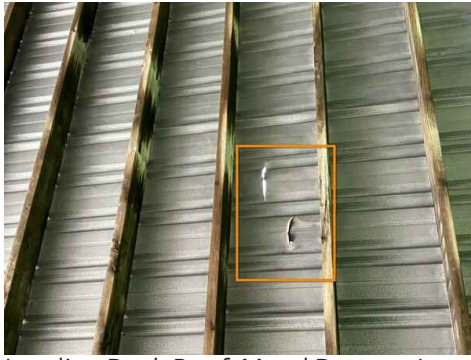
Loading Dock Roof, Metal Damage/
Roof Leaks

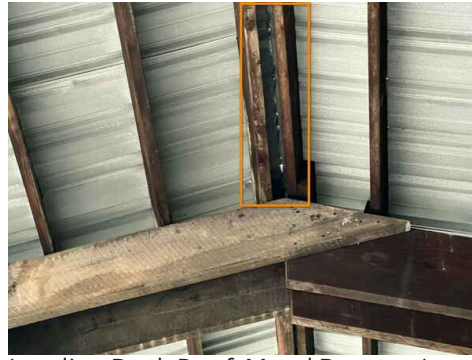
Loading Dock Roof, Metal Damage/
Roof Leaks

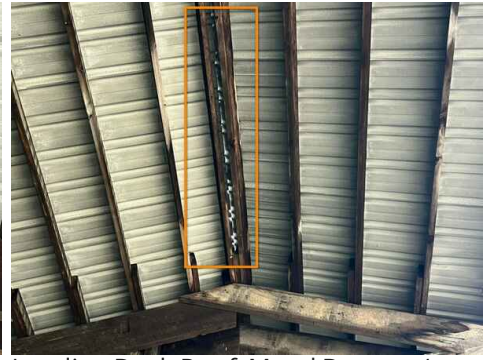
Loading Dock Roof, Metal Damage/
Roof Leaks

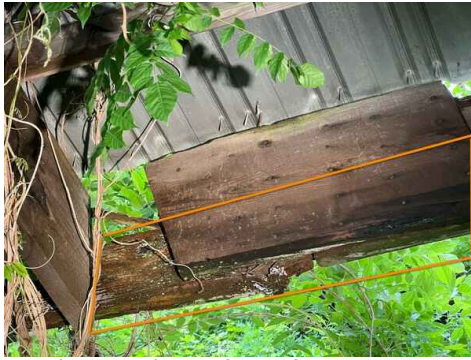
Loading Dock Roof, Roof Framing,
Rotted Wood

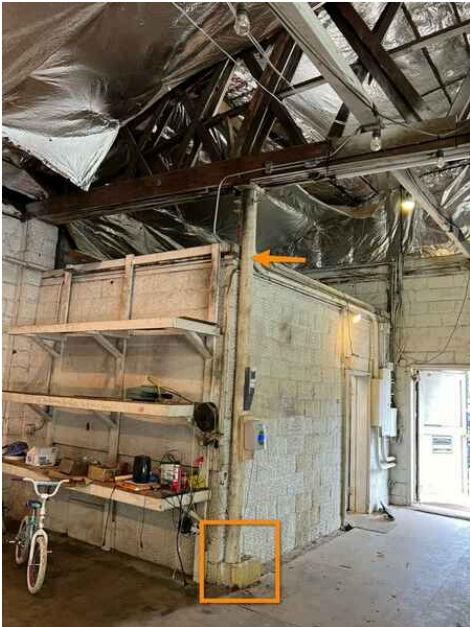
- In the warehouse, one of the roof trusses is rotted.
- This wood rot appears to be related to a historical roof leak.
- An additional support post has been added to stabilize the truss.
- This is a primary cause of the main warehouse roof being uneven.
- This roof truss appears to be stable.
- The post cannot be removed without repairing the truss.
- Ensure all roof leaks are repaired to prevent additional wood rot.

Main Warehouse, Rotted Truss, Supported By Post

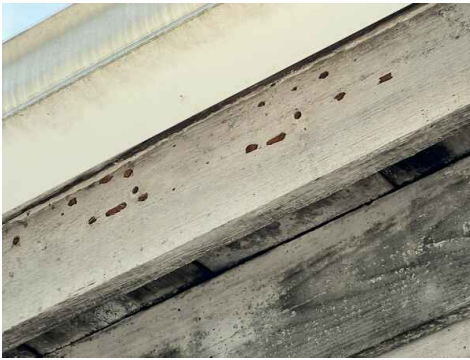
- Nearly 100% of the fascia and soffit on the warehouse is rotted, damaged, or missing.
- There is carpenter bee damage in some areas.
- This is more than a cosmetic issue.
- This will allow water to penetrate the building, rot the main roof framing materials, and allow unwanted pests to enter the building.

Left Side of Warehouse, Carpenter Bee Damage - Example

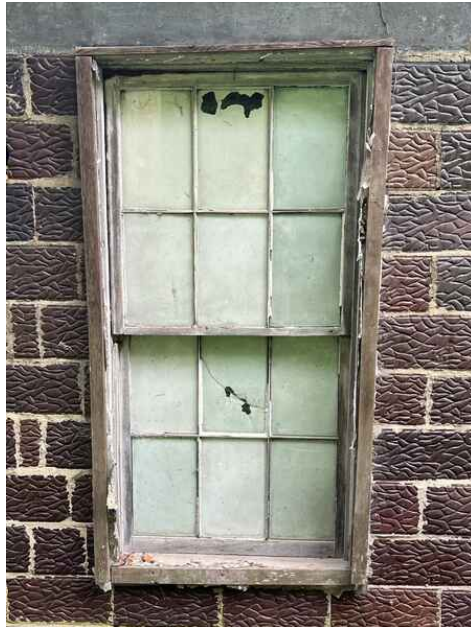
- All of the wood trim around the exterior doors and windows is deteriorated.
- This is more than a cosmetic issue.
- This allows exterior water to enter around the windows and door openings.

Example of Exterior Wood Component Deterioration

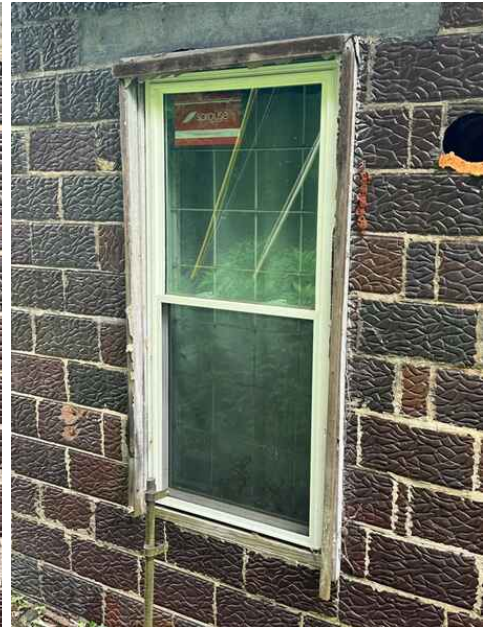
Example of Exterior Wood Component Deterioration

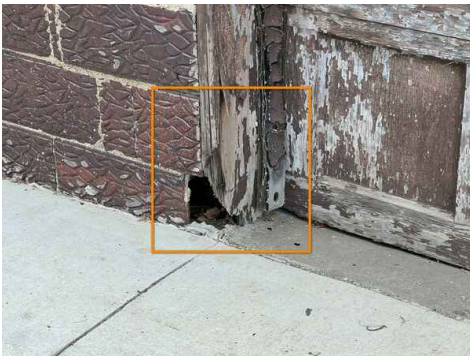
Example of Exterior Wood Component Deterioration

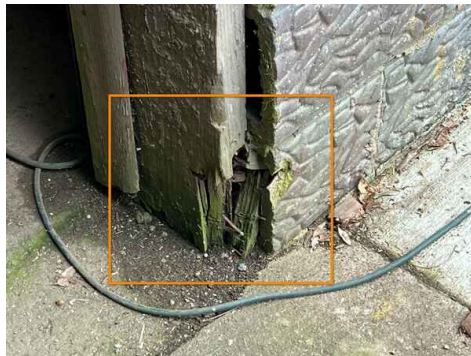
Example of Exterior Wood Component Deterioration

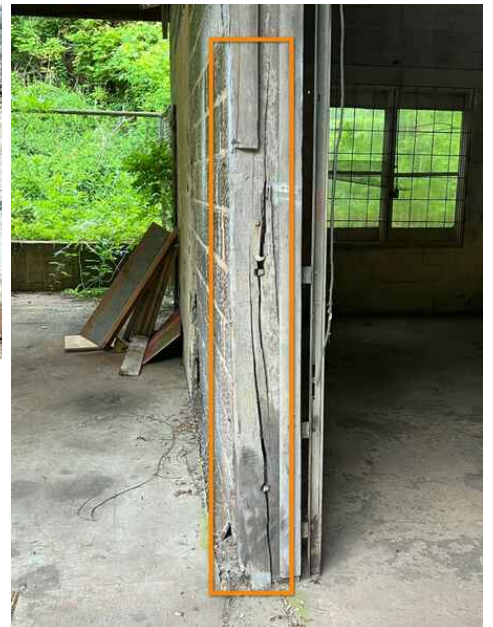
Example of Exterior Wood Component Deterioration

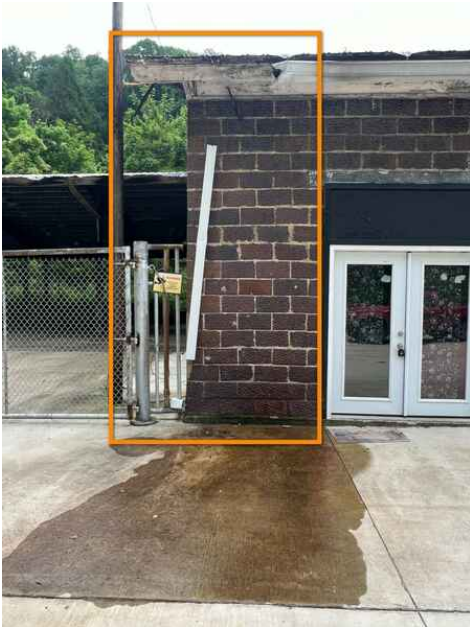
- All gutters and downspout piping need attention.
- In some areas, gutters and downspouts are missing.
- The gutters are damaged, leaking, and improperly sloped.

Left Side of Warehouse, Gutter and Downspout Damaged

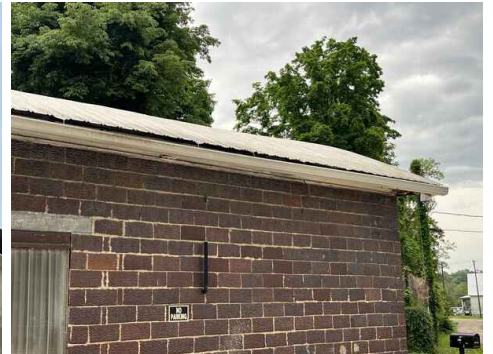
Left Side of Warehouse, Gutter and Downspout Damaged

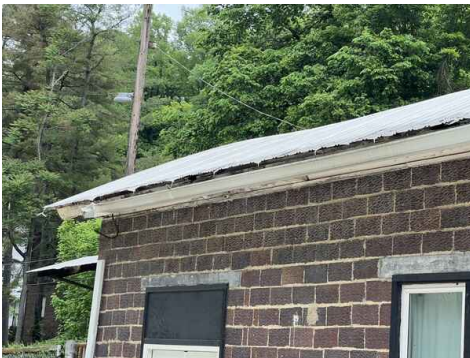
Left Side of Warehouse, Gutter and Downspout Damaged

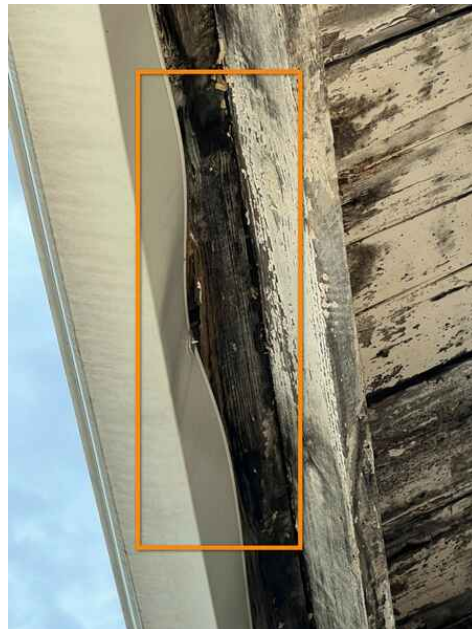
Left Side of Warehouse, Gutter and Downspout Damaged

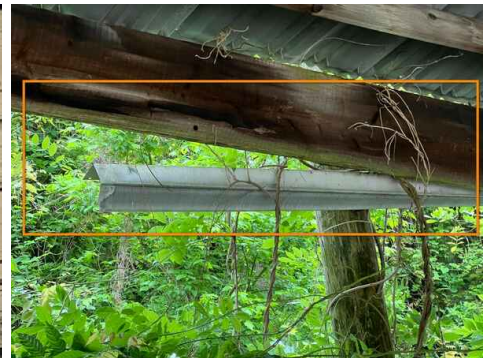
Right Side of Loading Dock Area, Gutter and Downspout Damaged

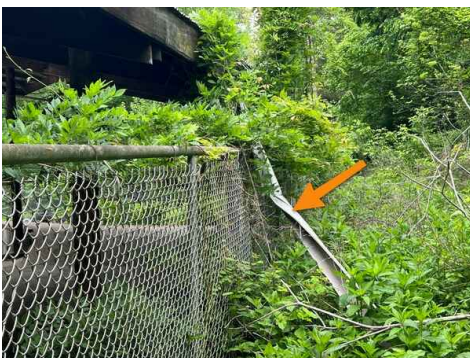
Right Side of Loading Dock Area, Gutter and Downspout Damaged

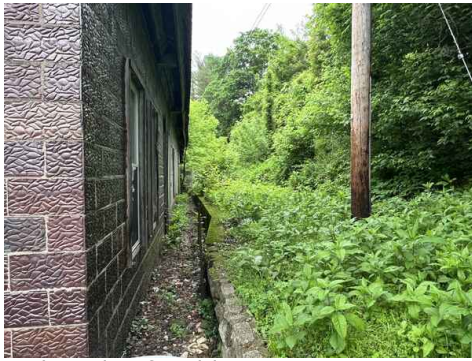
- On the right side of the building, the property slopes toward the building.
- This area is very wet. This is contributing to high moisture and exterior wood rot.
- This negative grading can also lead to water intrusion into the building.
- This is also a likely contributing factor to the cracks in the building foundation and block structure identified in this report.
- Recommend clearing this area so it can dry out and consider installing drains to capture and divert the water away from the building.

Right Side of Building, Negative Grading, Wet

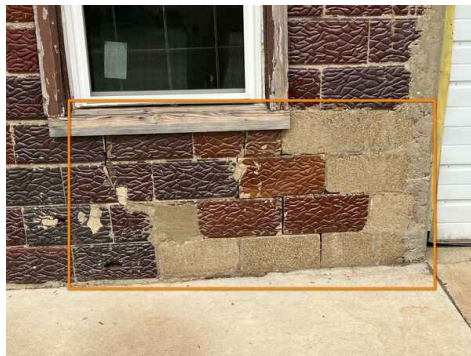
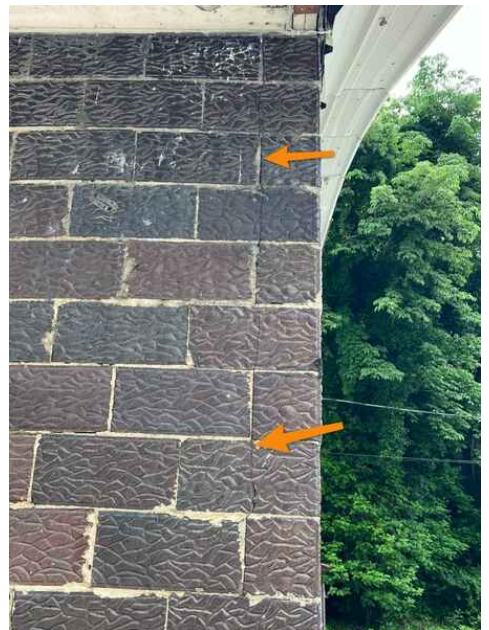
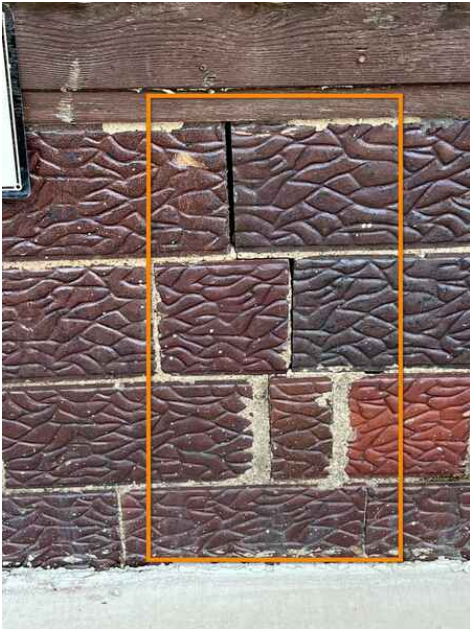
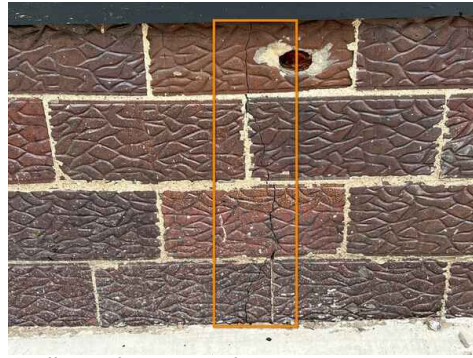
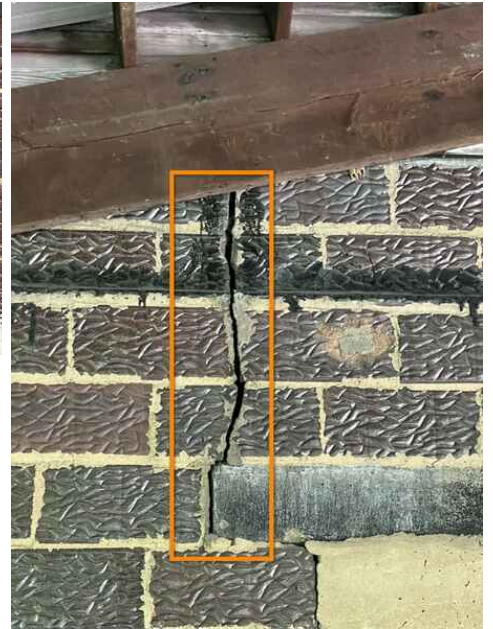
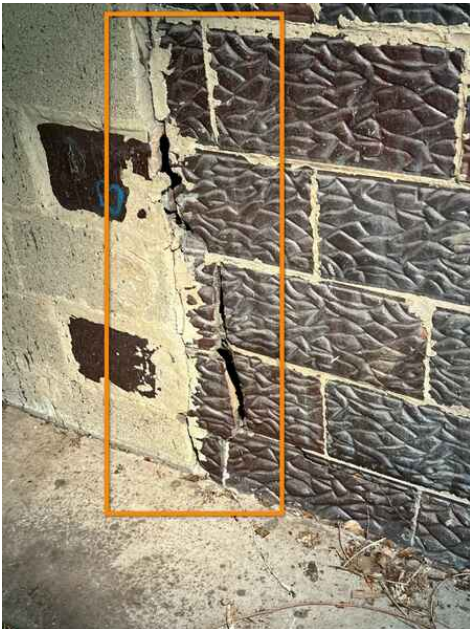
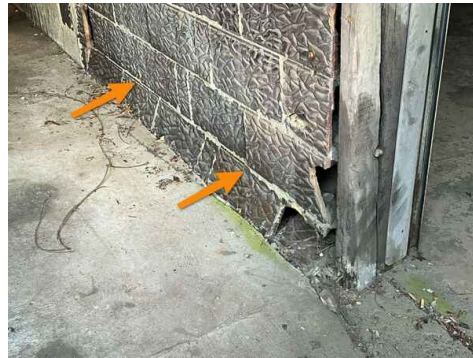
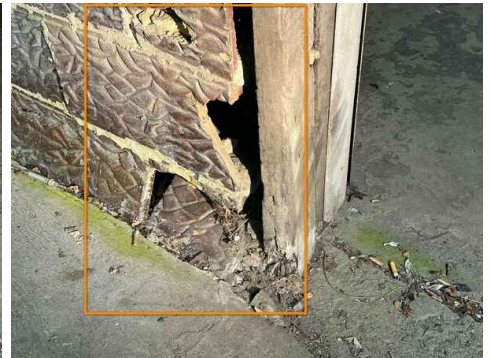
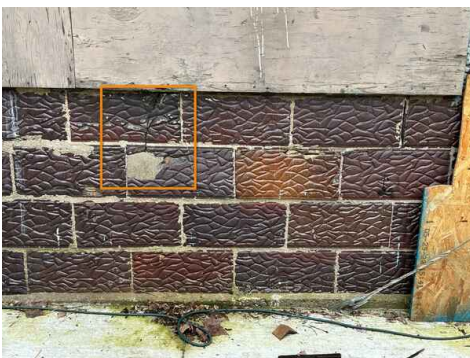
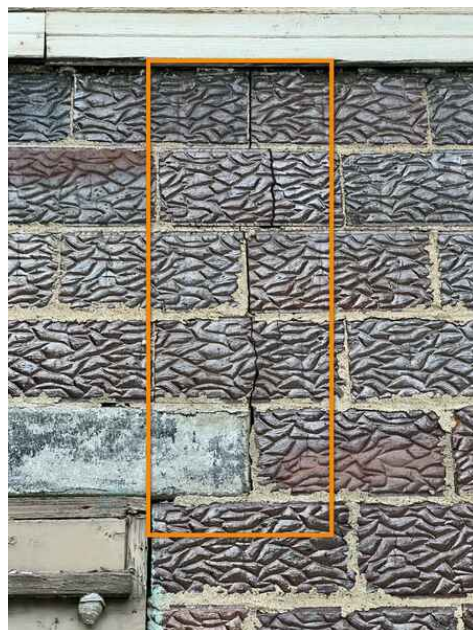
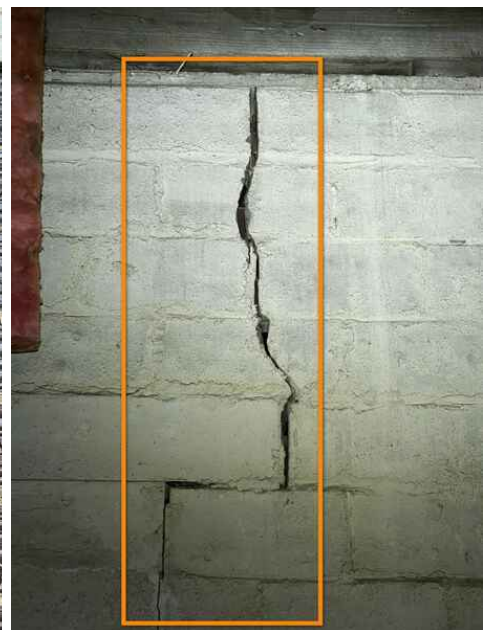
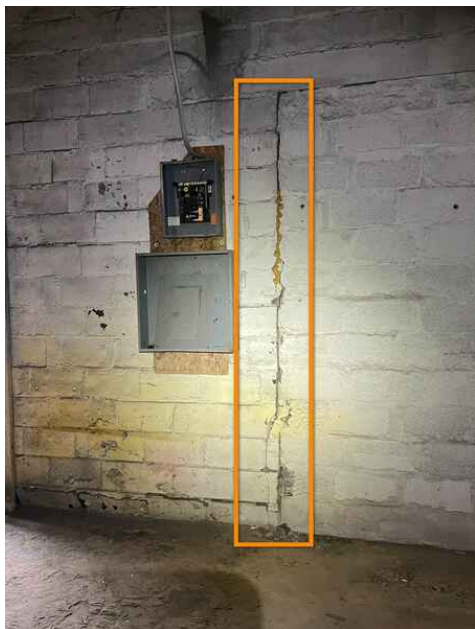
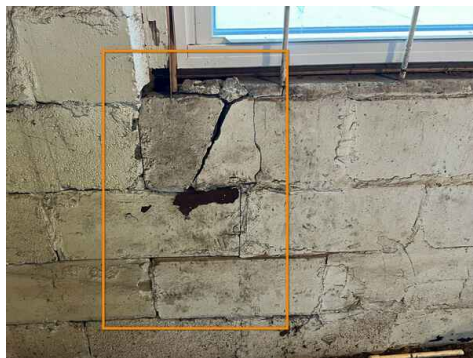
- There are many block wall cracks in the main warehouse building.
- These all appear to be historic.
- There was no direct evidence of recent movement.
- At the rear of the warehouse, at the loading dock door, it appears that the wall was impacted and pushed inward. This also does not show any signs of recent movement.
- The negative grading and any repeated water source (gutters) around the foundation are contributing factors.

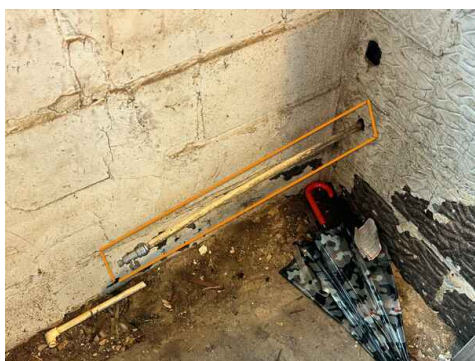
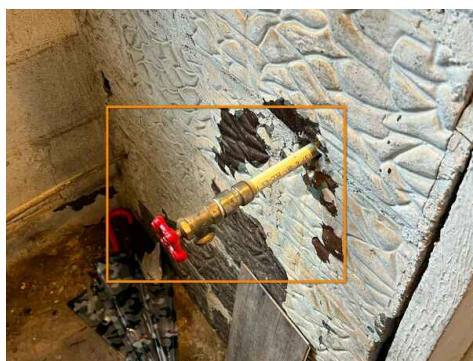
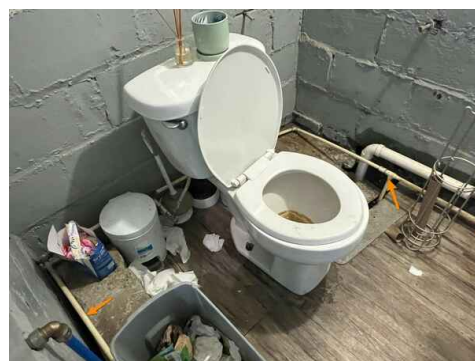
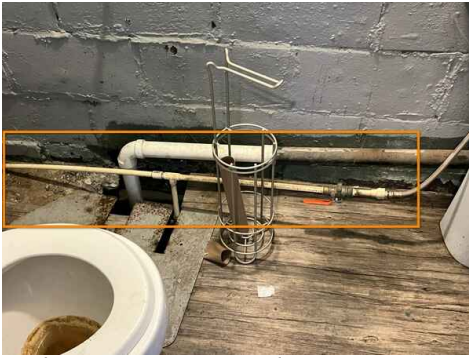
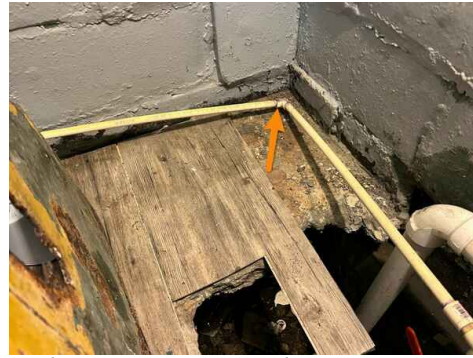
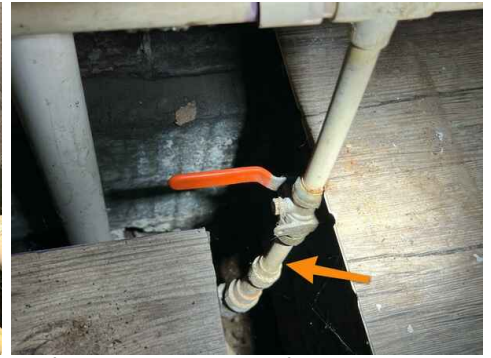
- The water supply lines are made from CPVC. CPVC is brittle and does not tolerate freezing temperatures.
- The water lines are improperly supported. This is very important with CPVC and can lead to water line cracks and leaks.
- Recommend upgrading the water lines to PEX pipe. PEX will not break when frozen, is flexible, and more suited to this application.

Bathroom, Water Supply Lines, Improperly Installed/ Supported

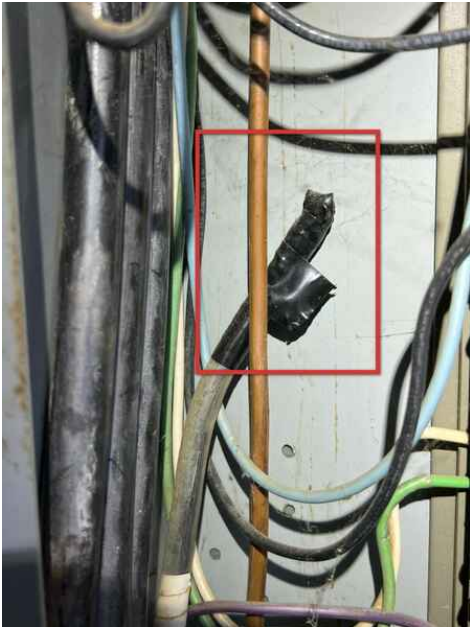
- There are stray, unused wires in several panels, recommend removal.
- Most panels are poorly labeled, this can be a safety hazard.
- There are openings in some panels that could allow unwanted pests to enter the panel and cause electrical safety hazards.
- There is a double-tapped 220V breaker in the "Party Room".
- There is an old fuse panel in the "Party Room", recommend replacement.
- There is aluminum or tin-coated wire in the fuse panel. Aluminum wire is prone to loosening, breaking, oxidizing, and other issues that increase the risk of an electrical fire. Recommend replacing.

Stray Electrical Panel Wires - Example

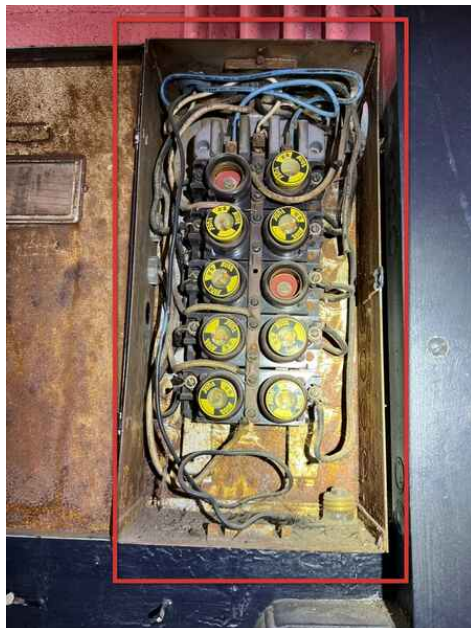
Fuse Panel, Recommend Replacement

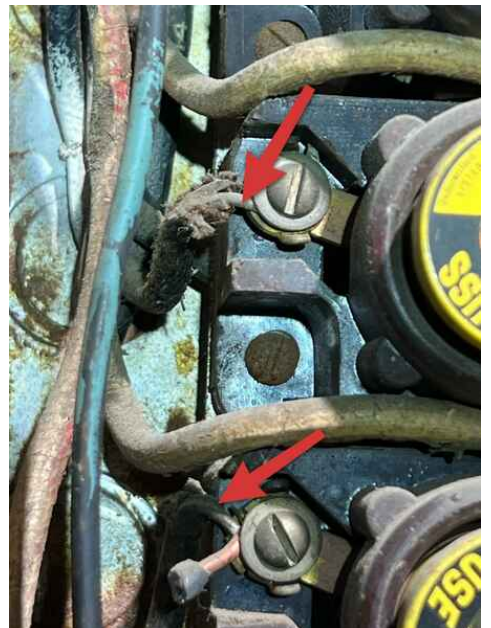
Aluminum Wire, Recommend Replacement

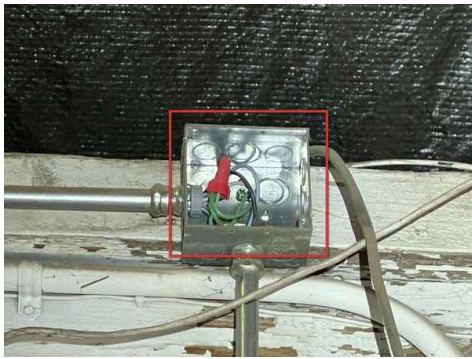
- There are many electrical junction boxes and receptacles missing covers.
- Some of the receptacles are improperly installed/ improperly secured.
- Some of the electrical wiring is outdated and does not contain a ground conductor.

Electrical Box Missing Cover - Example

Recommend evaluation, upgrade, and repair by a qualified and licensed commercial electrical contractor.

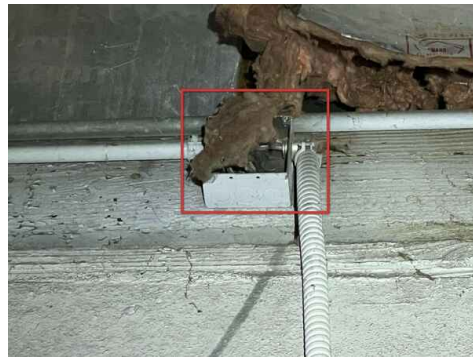
Electrical Box Missing Cover - Example

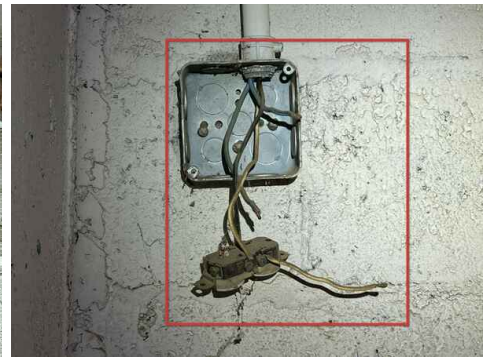
Exposed Electrical Wires

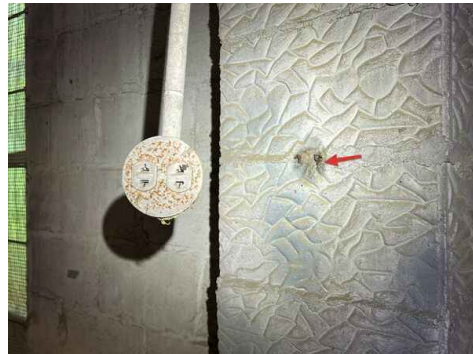
Receptacle Improperly Installed, Not Secure to Wall

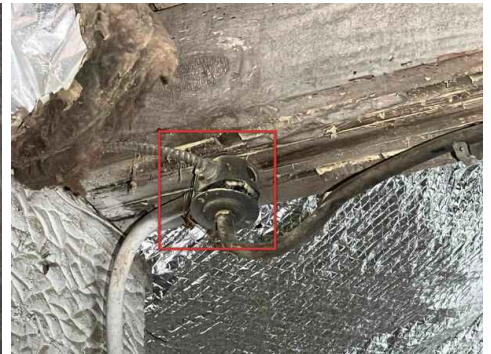
Electrical Junction Box Open, Potential for Water or Pest Intrusion

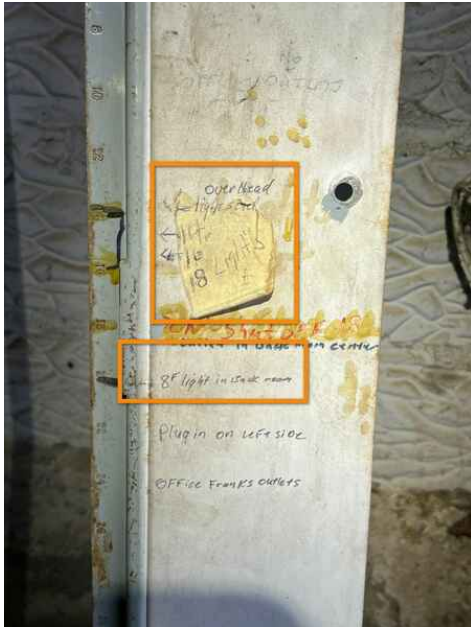
- Many lights are controlled by a breaker in an electrical panel. Electrical panel breakers are not designed to be turned on and off regularly. This can cause premature breaker failure and impact the breaker's ability to fail correctly in an electrical safety situation.
- Recommend all lighting be controlled by proper light system switches and controls.
- There are several damaged and missing light bulbs.
- The lighting can be upgraded to reduce potential electrical hazards, improve the overall illumination of the spaces and reduce operating costs.

Front Door Panel, Most Lights Controlled by Breakers

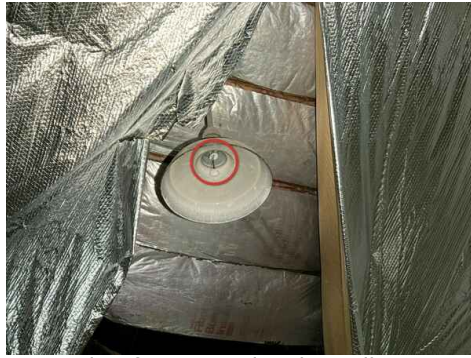
Example of Damaged Light Bulb

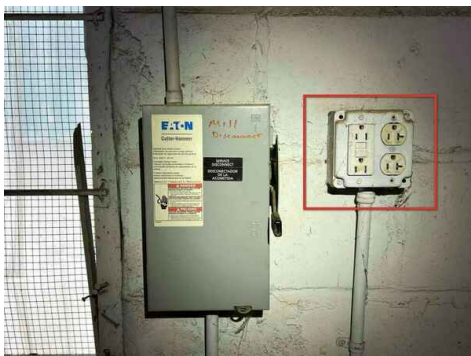
- 95% of the receptacles in the entire building are not GFCI protected.
- One of the installed GFCI receptacles failed when tested, it did not trip.
- GFCI protection is recommended for all receptacles that can be reached when standing outdoors on dirt, grass, etc., and when standing on concrete and unfinished floor surfaces.
- In addition, all interior receptacles within 5 1/2 feet of a water source such as a bathroom, breakroom area, wet workstations, etc should be GFCI protected.

GFCI Fails When Tested

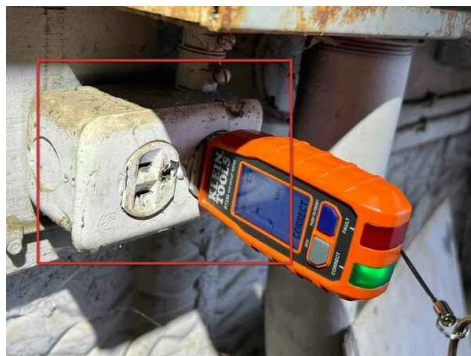
Example of Receptacles Not GFCI Protected (20-30+)

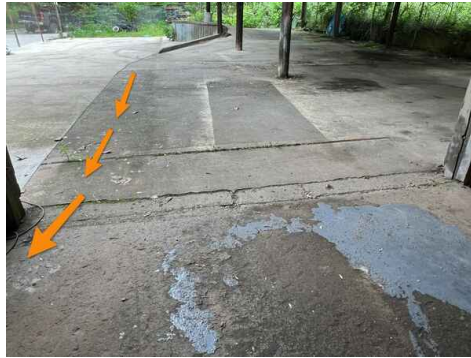
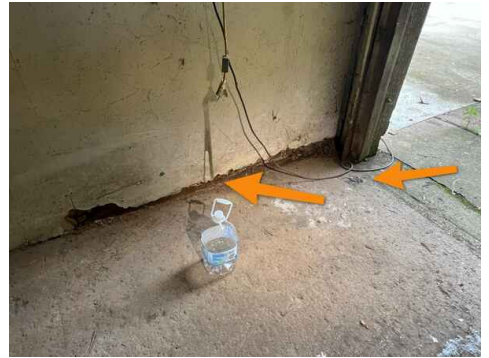
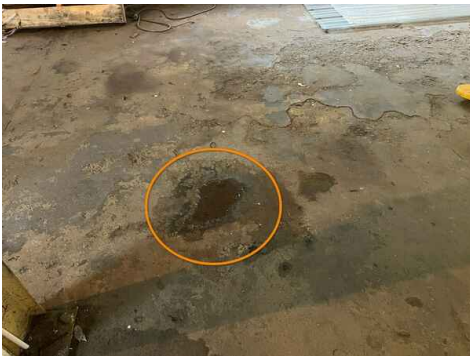
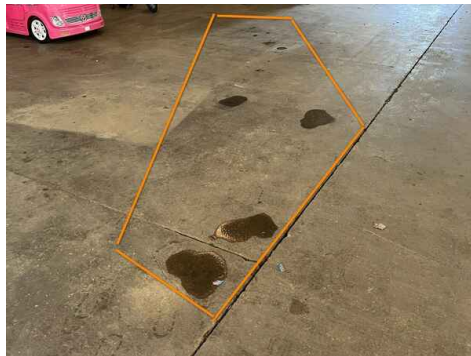
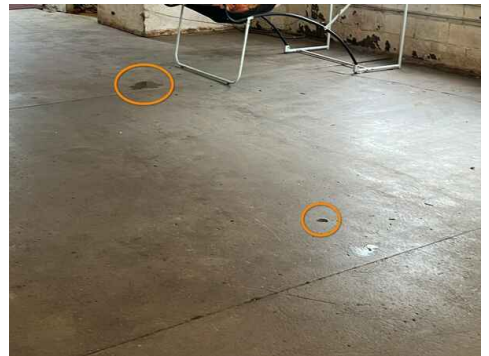
- As previously stated, there are active roof leaks. At the time of the inspection, the main warehouse floor was wet in 8+ locations.

Example of Active Roof Leak Water Intrusion

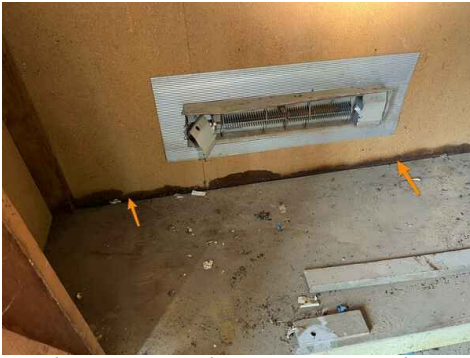
Inside Main Warehouse Storage Closet, Wall Wet, Likely Due to Active Roof Leak

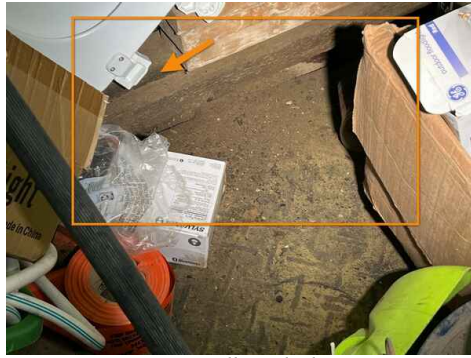
- As previously stated, in the storage room adjacent to the bathroom the floor and outside wall are bet. This is along the left side wall of the building. The gutters are likely the contributing factor.

Storage Room, Wall and Floor Wet, Dirt Coming in From Outside

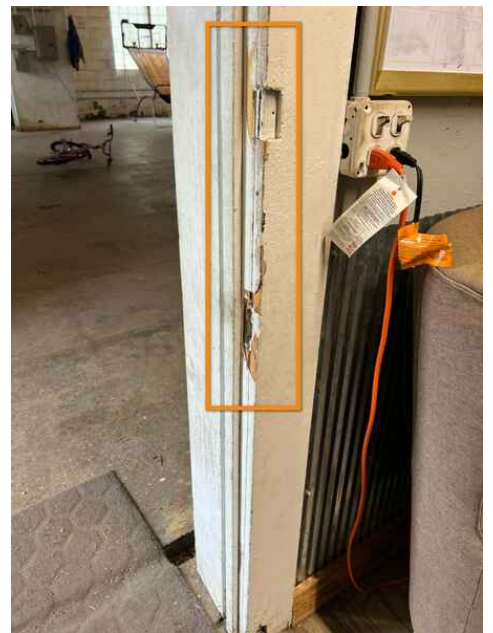
The door to the office area is not secure. The door frame is damaged and provides little protection if there is a desire to secure this area.

Office Door, Frame Damaged

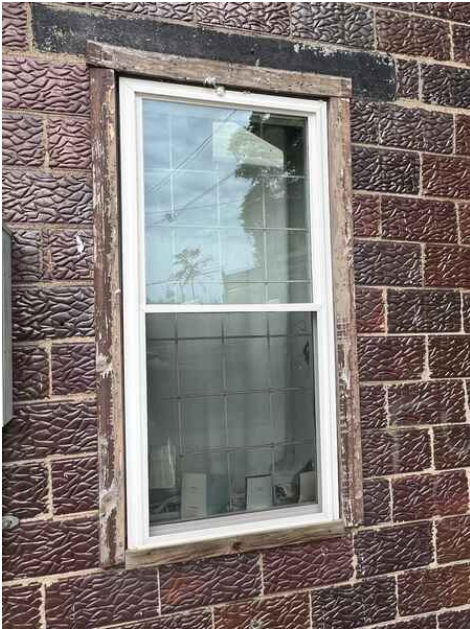
- Most of the windows in the building are many decades old.
- All of the windows are blocked out, covered, or otherwise block exterior light from entering the building.
- Several of the windows are cracked.
- The windows were not tested due to inaccessibility and to prevent potential damage.
- Consider upgrading the windows for not only natural light but to also improve insulation and weather tightness of the building.

Example Window

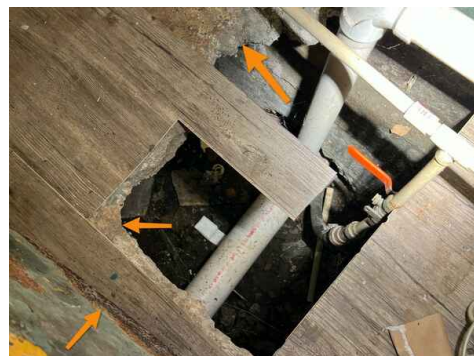
- In the "party room", the floor finish is deteriorated and presents a trip/ fall hazard. This appears to be due to the water intrusion into the room identified in this report.
- In the bathroom, the floor is rotted and has been cut out.
- In the storage room next to the bathroom, there is active water intrusion. The floor was wet and there is a potential for additional damage not visible due to the contents stored in this room.

Bathroom, Example of Floor Rot/ Deterioration

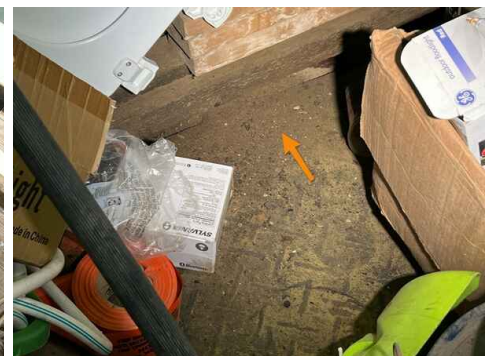
Storage Room, Evidence of Active Water Intrusion - Wet

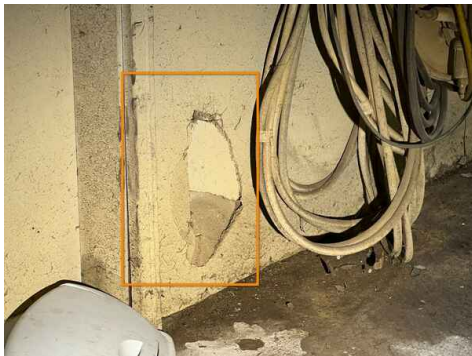
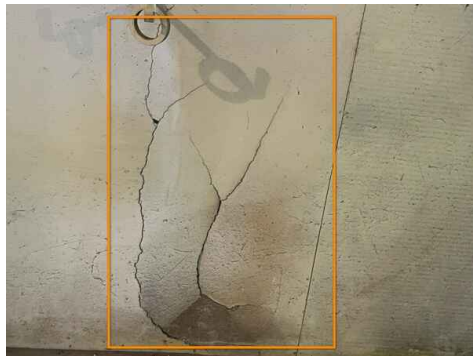
- All observed wall damage and deterioration appear to be cosmetic.
- In most cases, the damage appears to have been caused by past workers.
- In the rear warehouse space, near the garage door to the loading dock, the wall damage is related to water intrusion from the exterior coming under the garage door.

Example of Cosmetic Wall Damage

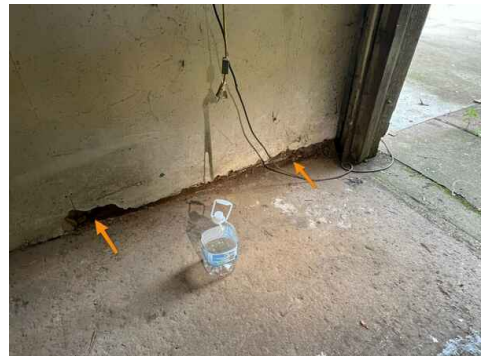
Wall Damage, Rear Warehouse Space, Water Intrusion

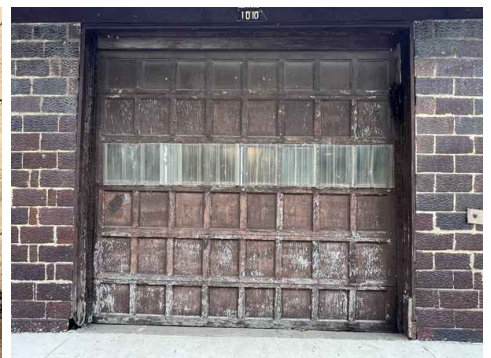
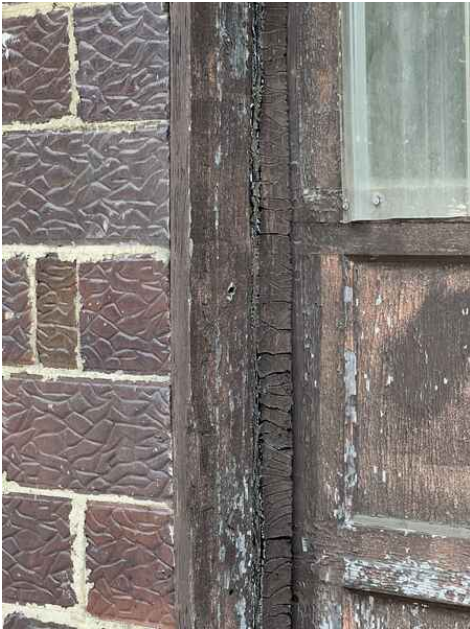
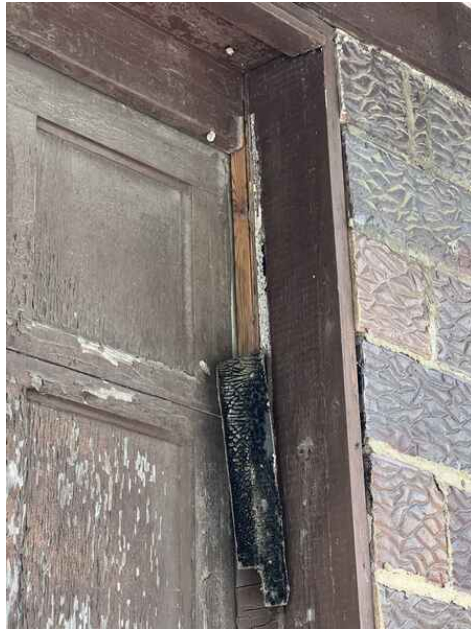
- The front garage door was secured. It was not tested.
- All tested garage doors need, at minimum, adjustment and lubrication.
- The left side garage door is severely weathered, including the wood trim and all door seals.

Left Garage Door Deteriorated

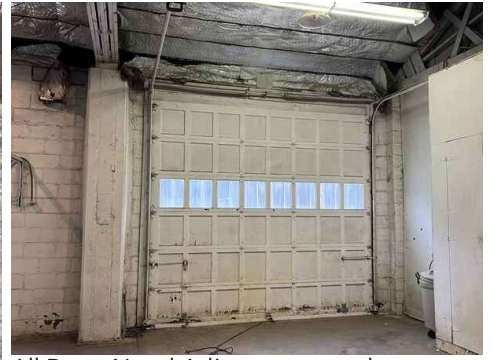
All Door Need Adjustment and Lubrication - Example

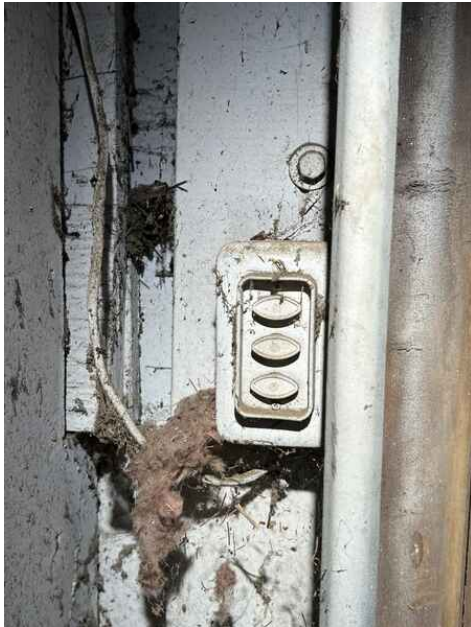
- None of the garage doors have an active, operating automatic opener.
- There are two doors with garage door openers, however, they are no longer connected to the doors.
- When tested, the rear garage door opener did appear to operate.
- The front garage door opener was not tested due to the door being secured to prevent damage.

Front Garage Door Control - Example
