TRI-STATE SMART HOME SOLUTIONS LLC

COMMERCIAL INSPECTION

1234 Main Street
Gallipolis, OH 45631

Buyer Name
07/15/2024 9:00AM

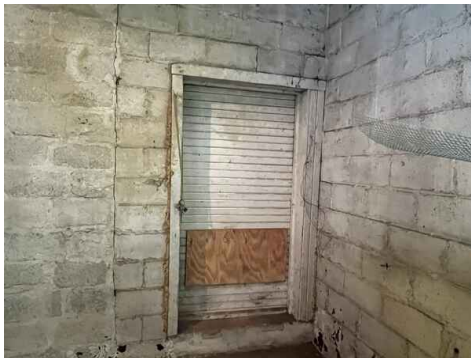
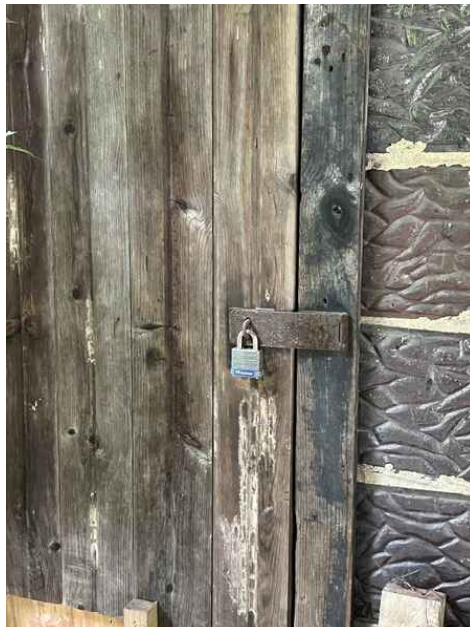
ROOM NOT INSPECTED - NO ACCESS

Rear Warehouse Space, Locked Room, Not Inspected

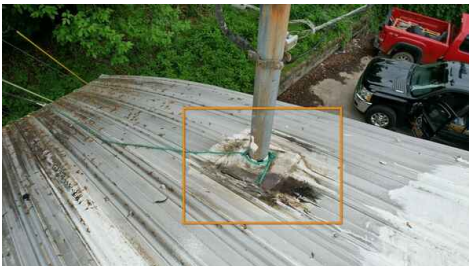
- There are active roof leaks in both the warehouse roof and the loading dock area roof.
- The warehouse roof seams and fasteners need to be resealed and re-coated, they are leaking.
- The flashing around the main power entrance cables needs to be replaced on the main warehouse roof.
- The loading dock area roof has visible holes in the roof and the roof metal is damaged in several areas.
- The wood framing, eaves, and soffit areas of both roofs are rotted and deteriorated in some areas.

Warehouse Roof, Flashing Deterioration

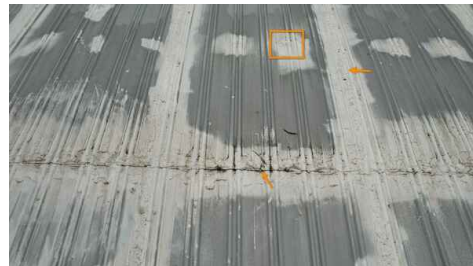
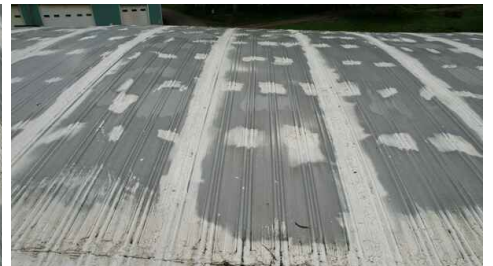
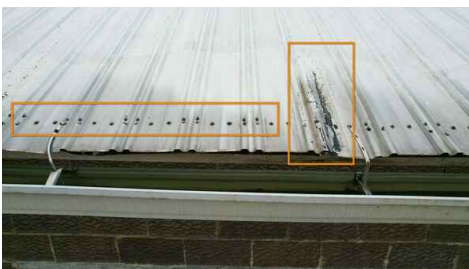
Warehouse Roof, Metals Seams and Fasteners Need Sealed

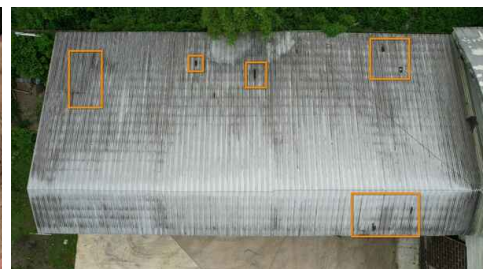
Loading Dock Roof, Metal Damage/ Roof Leaks

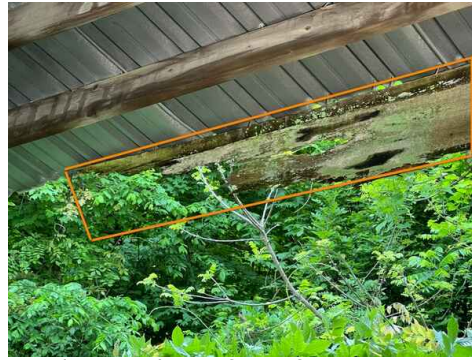
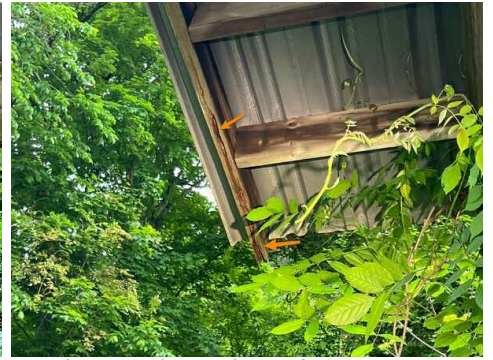
Loading Dock Roof, Roof Framing,
Rotted Wood

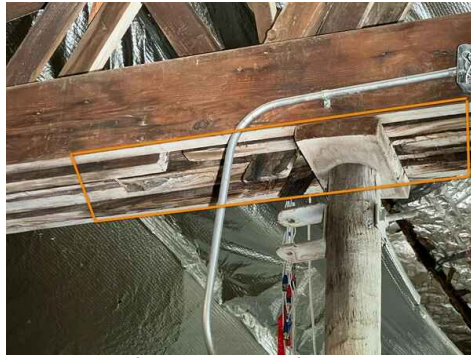
- In the warehouse, one of the roof trusses is rotted.
- This wood rot appears to be related to a historical roof leak.
- An additional support post has been added to stabilize the truss.
- This is a primary cause of the main warehouse roof being uneven.
- This roof truss appears to be stable.
- The post cannot be removed without repairing the truss.
- Ensure all roof leaks are repaired to prevent additional wood rot.

Main Warehouse, Rotted Truss, Supported By Post

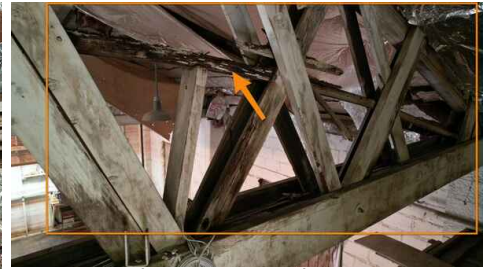
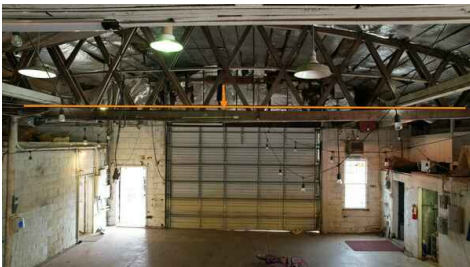
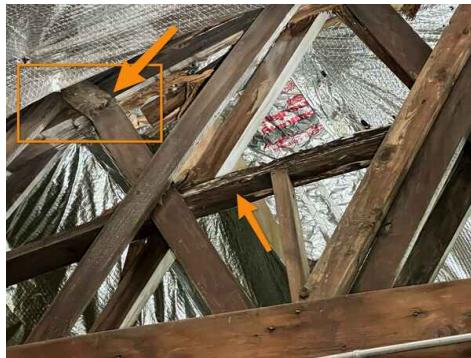
Main Warehouse, Rotted Truss

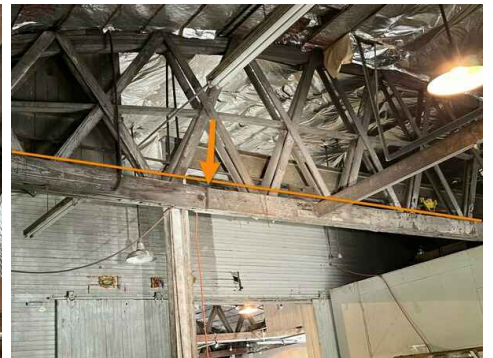
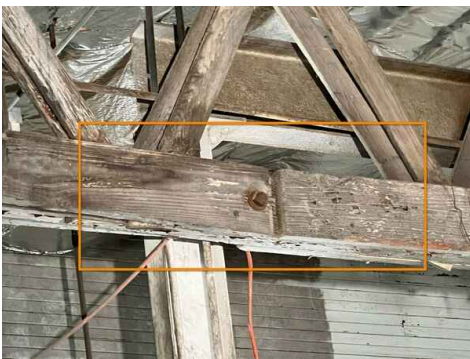
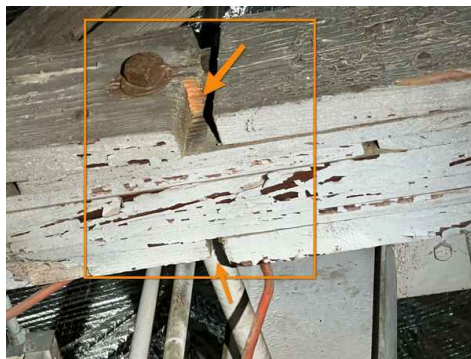
- One of the trusses is sagging. This appears to be related to wood rot combined with improper construction.
- The wood appears dry and the wood rot appears to be historic.
- 4 framing members make up the bottom of the truss. Multiple joints in these framing members occur in the same location. These joints should be staggered in a manner that only a single joint should occur in a given location across the beam.
- Recommend further evaluation. The addition of a support post and/or repairs may be necessary for long-term stability.

Rear Warehouse, Weekend Truss

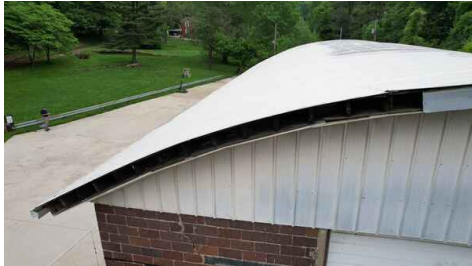
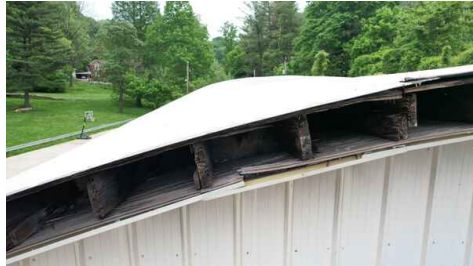
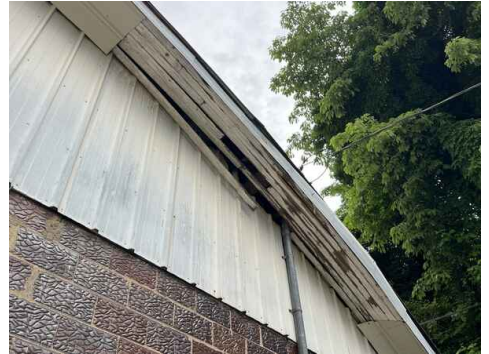
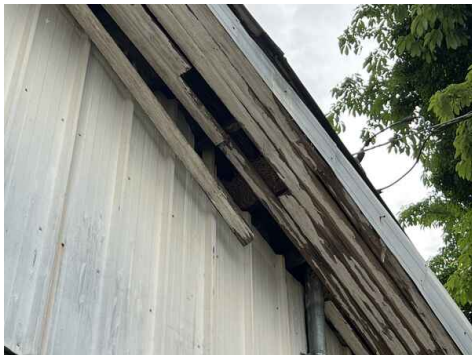
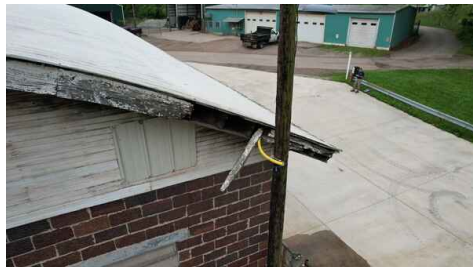
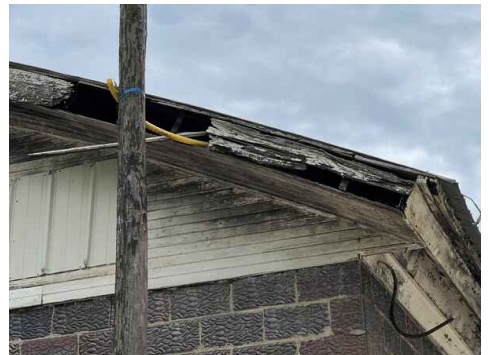
- Nearly 100% of the fascia and soffit on the warehouse is rotted, damaged, or missing.
- There is carpenter bee damage in some areas.
- This is more than a cosmetic issue.
- This will allow water to penetrate the building, rot the main roof framing materials, and allow unwanted pests to enter the building.

Front of Warehouse

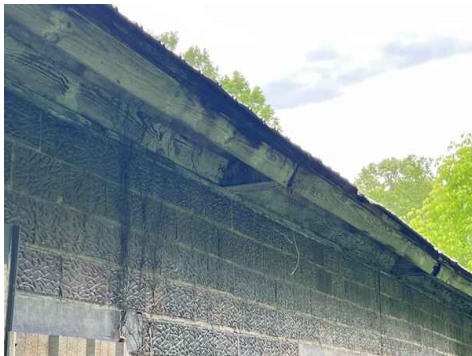
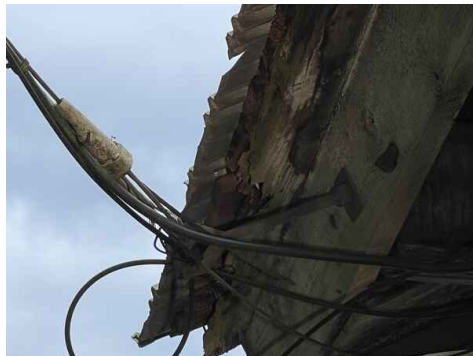
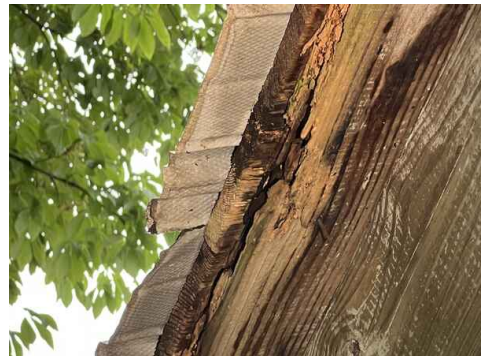
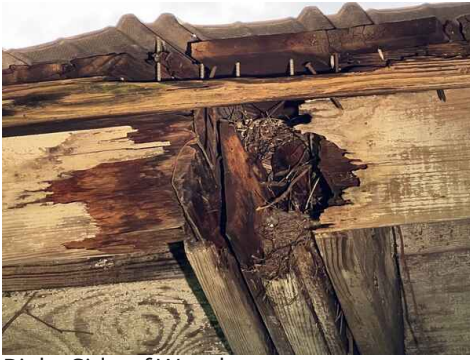
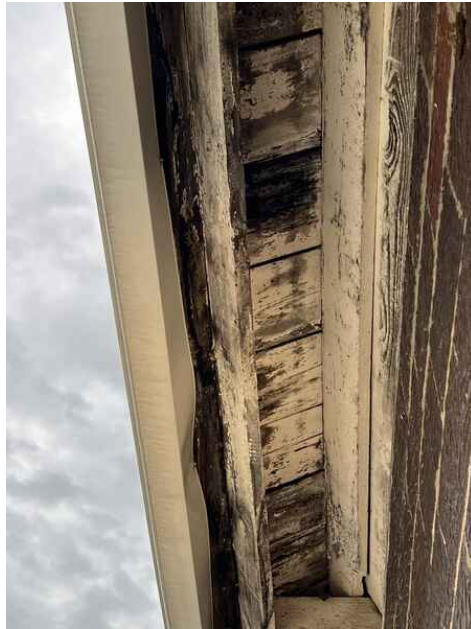
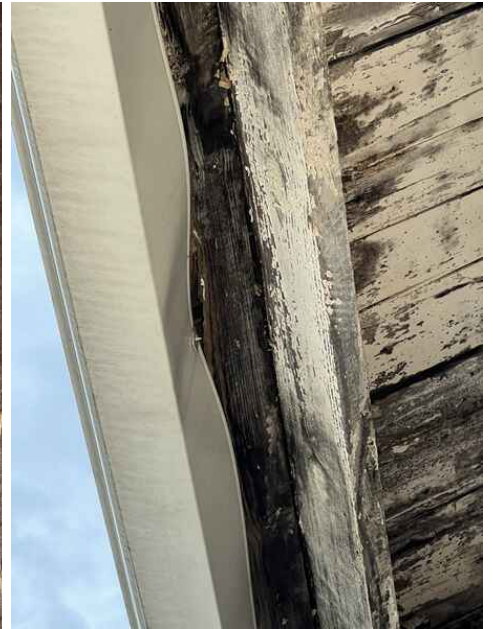
Right Side of Warehouse

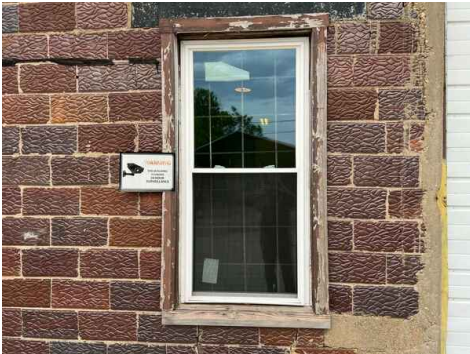
- All of the wood trim around the exterior doors and windows is deteriorated.
- This is more than a cosmetic issue.
- This allows exterior water to enter around the windows and door openings.

Example of Exterior Wood Component Deterioration

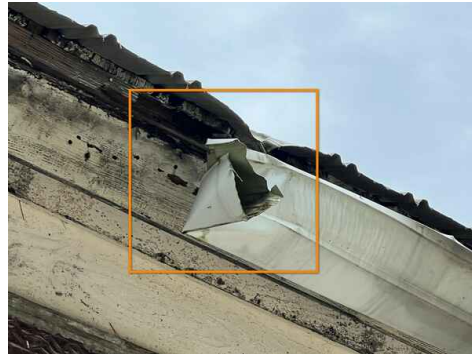
- All gutters and downspout piping need attention.
- In some areas, gutters and downspouts are missing.
- The gutters are damaged, leaking, and improperly sloped.

Left Side of Warehouse, Gutter and Downspout Damaged

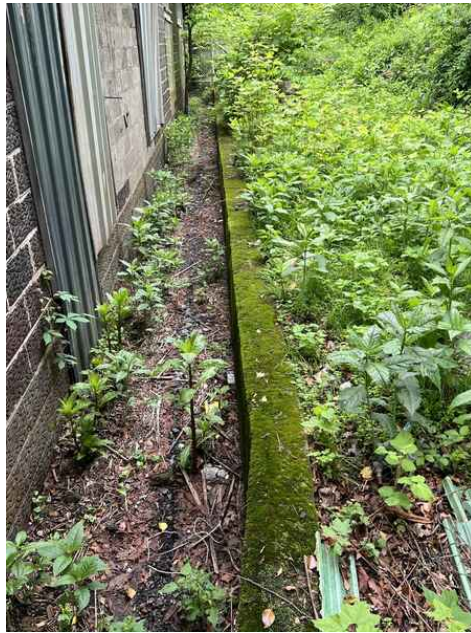
- On the right side of the building, the property slopes toward the building.
- This area is very wet. This is contributing to high moisture and exterior wood rot.
- This negative grading can also lead to water intrusion into the building.
- This is also a likely contributing factor to the cracks in the building foundation and block structure identified in this report.
- Recommend clearing this area so it can dry out and consider installing drains to capture and divert the water away from the building.

Right Side of Building, Negative Grading, Wet

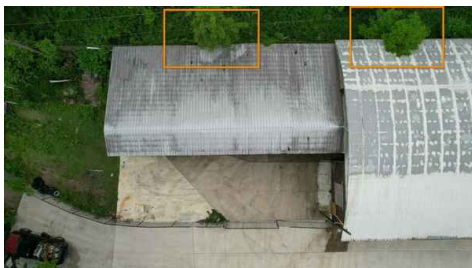
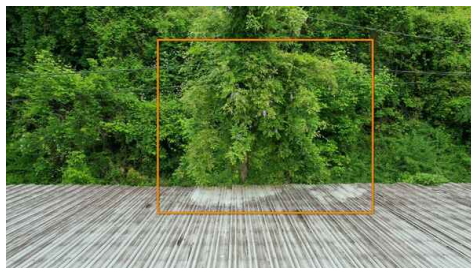
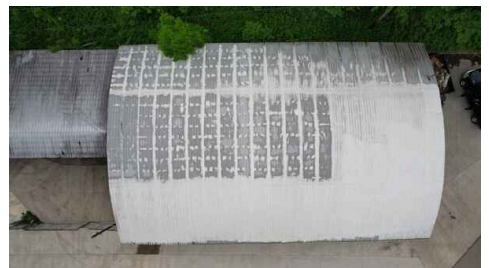
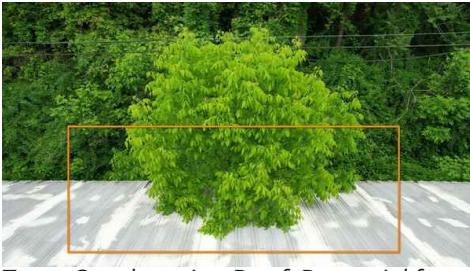
Trees are overhanging the building. Falling branches can cause damage to the roof and leaves can prevent proper drainage by clogging the gutters and downspouts. The trees can also shade the roof leading to moss buildup and future roof leaks. Recommend trimming back.

Trees Overhanging Roof, Potential for Damage and Gutters Being Clogged

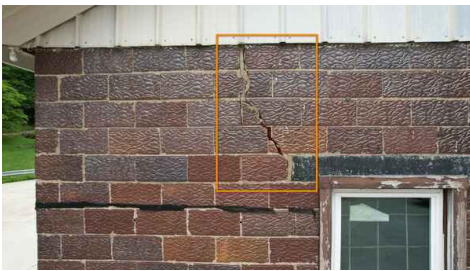
- There are many block wall cracks in the main warehouse building.
- These all appear to be historic.
- There was no direct evidence of recent movement.
- At the rear of the warehouse, at the loading dock door, it appears that the wall was impacted and pushed inward. This also does not show any signs of recent movement.
- The negative grading and any repeated water source (gutters) around the foundation are contributing factors.

Wall Crack - Example

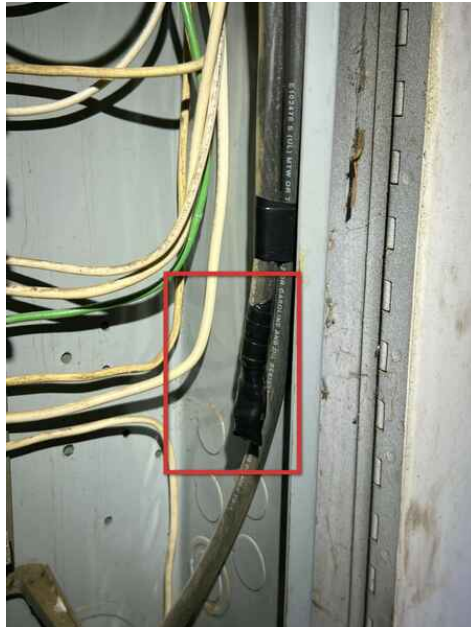
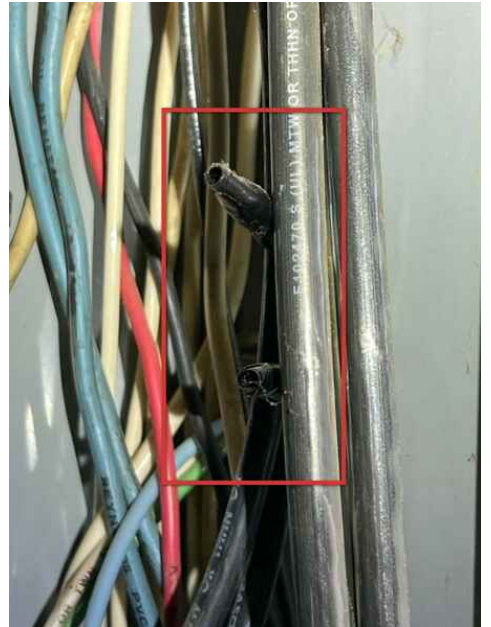
- There are stray, unused wires in several panels, recommend removal.
- Most panels are poorly labeled, this can be a safety hazard.
- There are openings in some panels that could allow unwanted pests to enter the panel and cause electrical safety hazards.
- There is a double-tapped 220V breaker in the "Party Room".
- There is an old fuse panel in the "Party Room", recommend replacement.
- There is aluminum or tin-coated wire in the fuse panel. Aluminum wire is prone to loosening, breaking, oxidizing, and other issues that increase the risk of an electrical fire. Recommend replacing.

Stray Electrical Panel Wires - Example

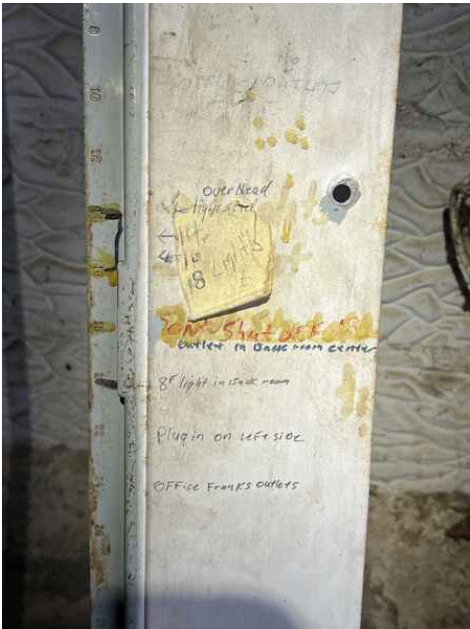
Poor Labeling - Example

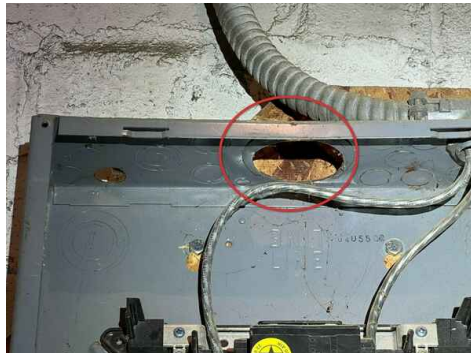
Opening in Panel - Example

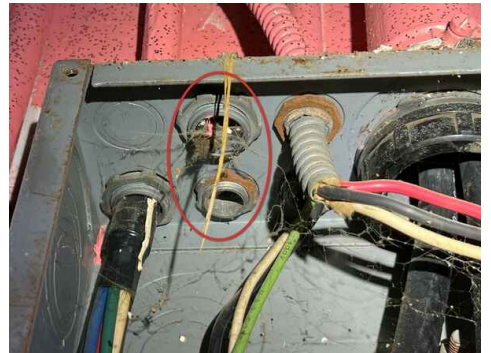
Opening in Panel - Example

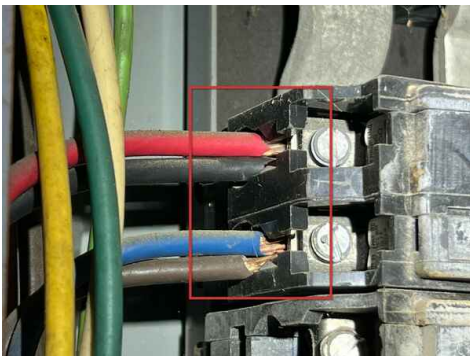
Double Tapped Breaker

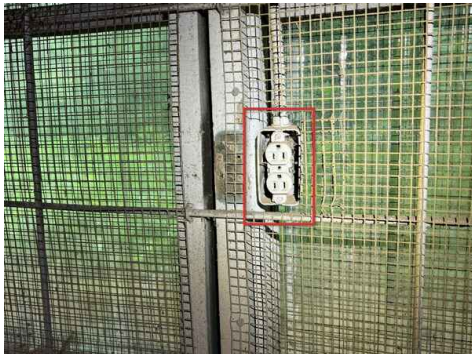
- There are many electrical junction boxes and receptacles missing covers.
- Some of the receptacles are improperly installed/ improperly secured.
- Some of the electrical wiring is outdated and does not contain a ground conductor.

Receptacle Missing Cover - Example

Recommend evaluation, upgrade, and repair by a qualified and licensed commercial electrical contractor.

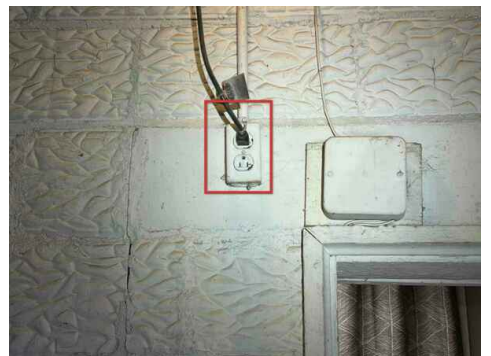
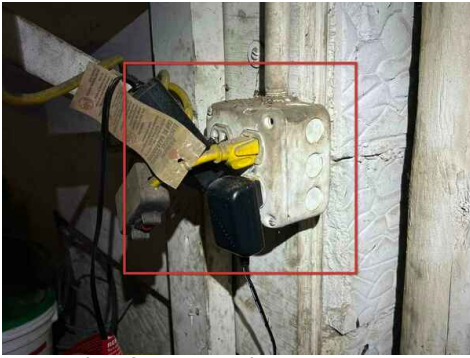
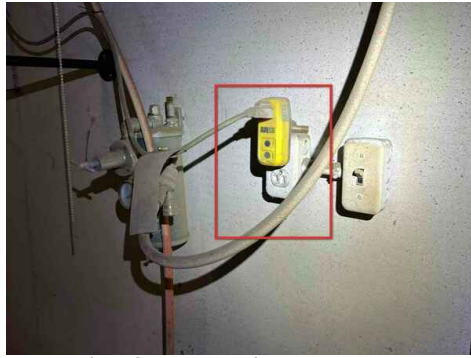
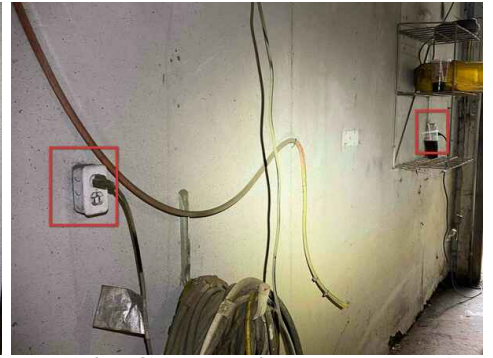
- 95% of the receptacles in the entire building are not GFCI protected.
- One of the installed GFCI receptacles failed when tested, it did not trip.
- GFCI protection is recommended for all receptacles that can be reached when standing outdoors on dirt, grass, etc., and when standing on concrete and unfinished floor surfaces.
- In addition, all interior receptacles within 5 1/2 feet of a water source such as a bathroom, breakroom area, wet workstations, etc should be GFCI protected.

Example of Receptacles Not GFCI Protected (20-30+)

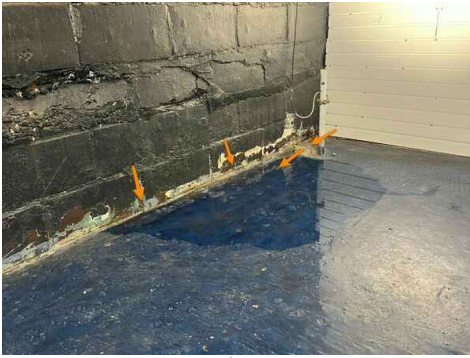
- There was water standing in the "Party Room" during the inspection.
- This water is coming from the exterior.
- The wall between the "Party Room" and the adjacent rear warehouse space is wet, damaged, and showing signs of wood rot, water entering under the rear garage door is occurring during rain events.
- There is also a potential with the missing fascia above this area and the damaged gutters, and downspouts on the left side of the building are also contributing factors.

Party Room - Standing Water

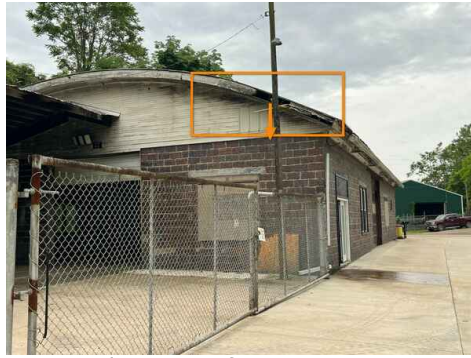
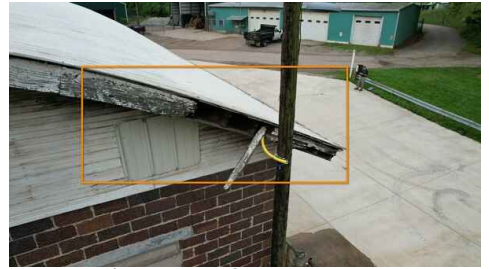
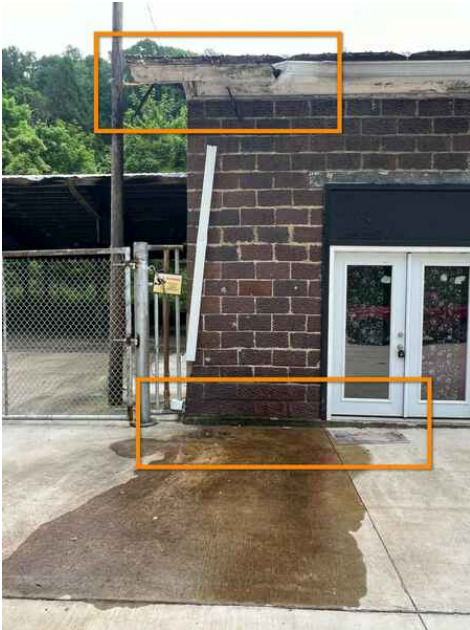
Potential Source of Party Room Standing Water

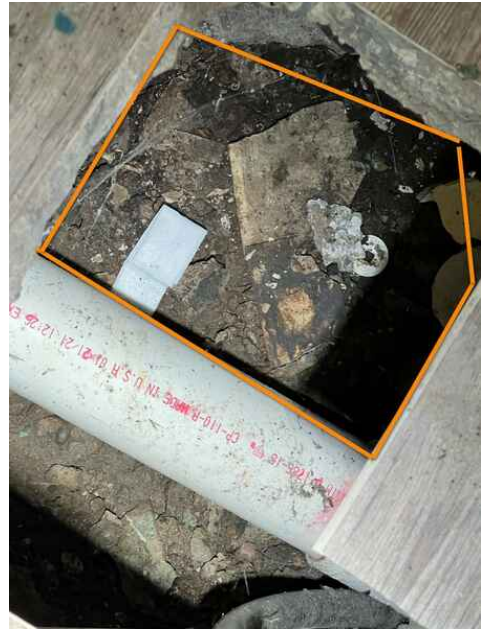
Below Bathroom Floor, Wet Soil

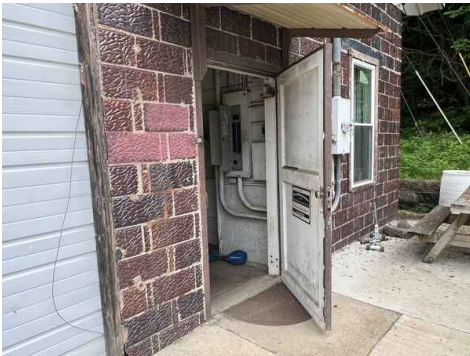
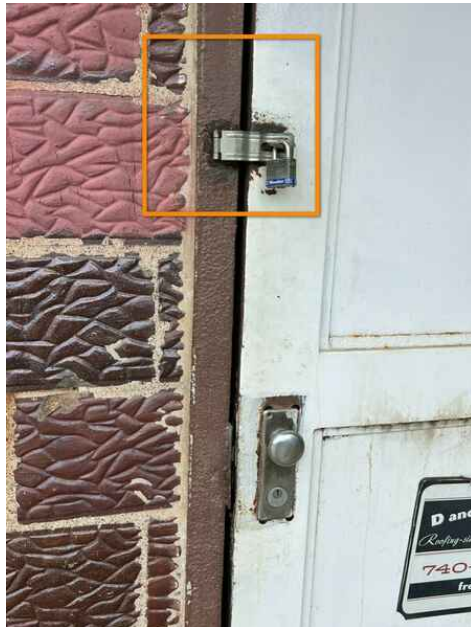
Front Door, Not Secure

Recommend upgrading all exterior door security. Most of the doors will not adequately prevent unwanted intruders from entering the building.

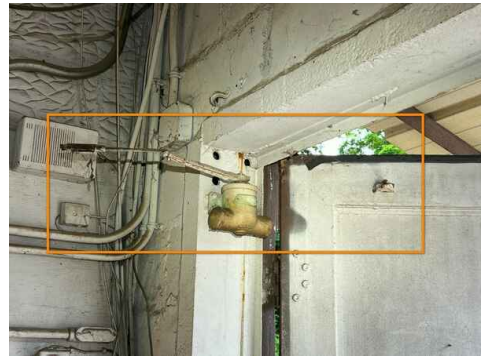
Front Door, Closure Disconnected

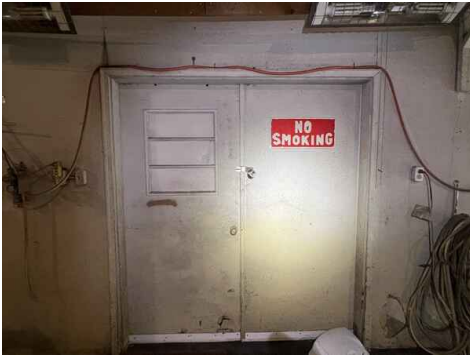
Door to "Party Room", Does Not Operating or Secure Correctly

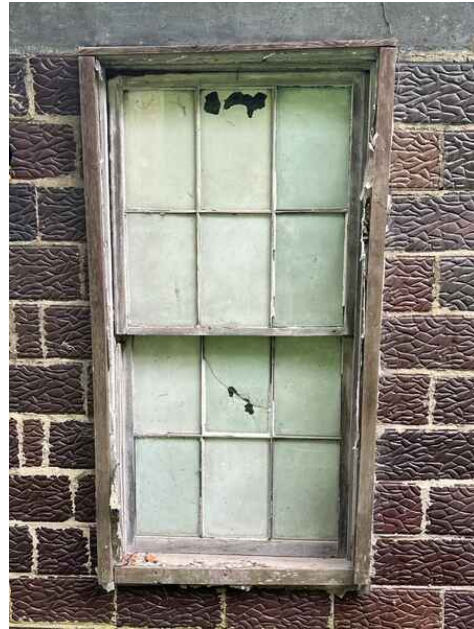
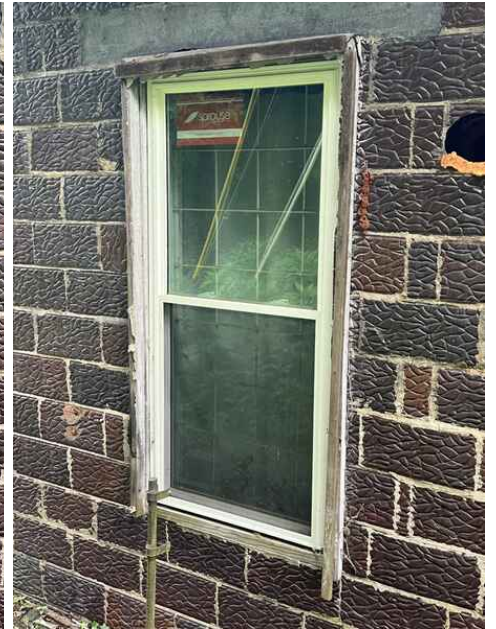
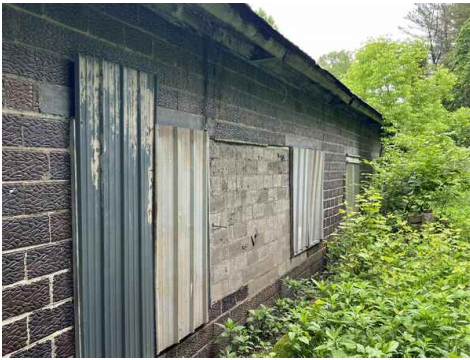
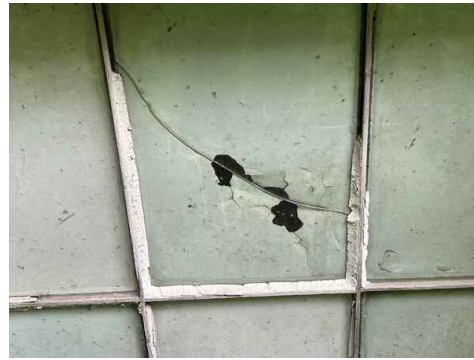
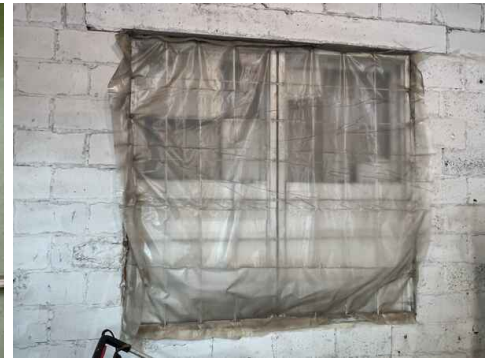
- Most of the windows in the building are many decades old.
- All of the windows are blocked out, covered, or otherwise block exterior light from entering the building.
- Several of the windows are cracked.
- The windows were not tested due to inaccessibility and to prevent potential damage.
- Consider upgrading the windows for not only natural light but to also improve insulation and weather tightness of the building.

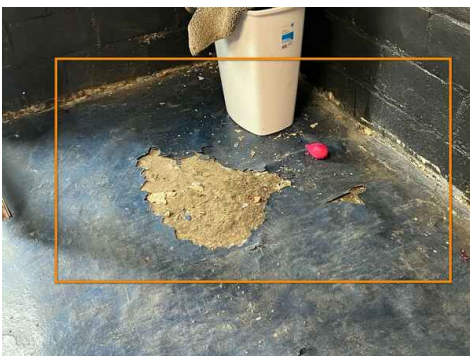
- In the "party room", the floor finish is deteriorated and presents a trip/ fall hazard. This appears to be due to the water intrusion into the room identified in this report.
- In the bathroom, the floor is rotted and has been cut out.
- In the storage room next to the bathroom, there is active water intrusion. The floor was wet and there is a potential for additional damage not visible due to the contents stored in this room.

Party Room - Example of Flooring Deterioration

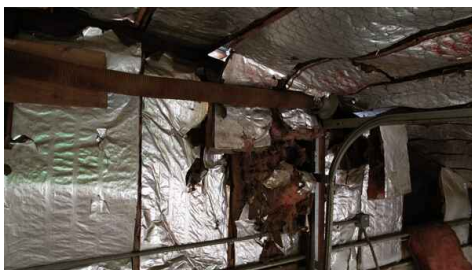
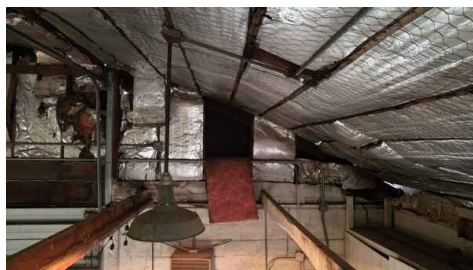
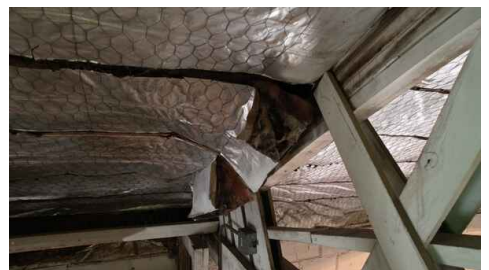
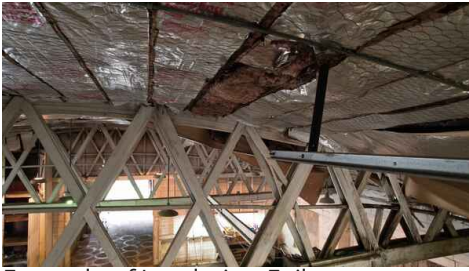
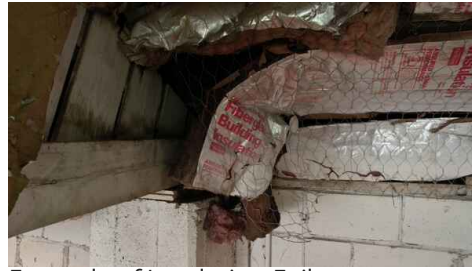
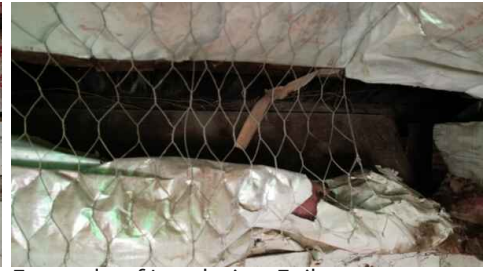
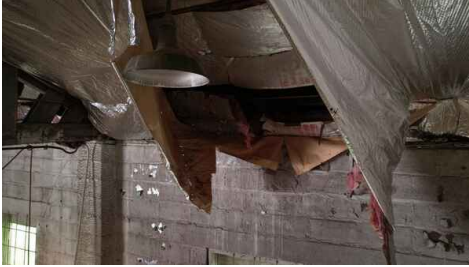
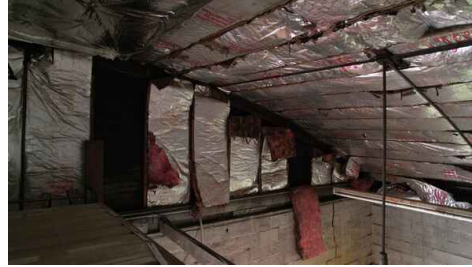
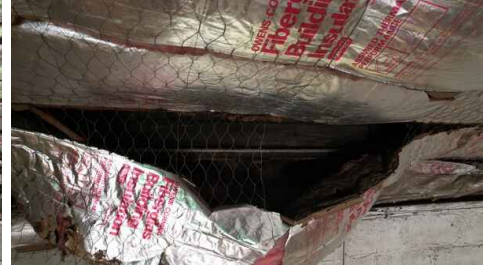
- As previously stated in this report, there are active roof leaks.
- These leaks are contributing to the ceiling insulation becoming wet, becoming heavy, and falling down or coming loose.
- Recommend resolving the roof leaks and restoring the insulation.
- During this process, an in-depth investigation should be completed to evaluate and potential damage hidden by the insulation.

Example of Insulation Failure

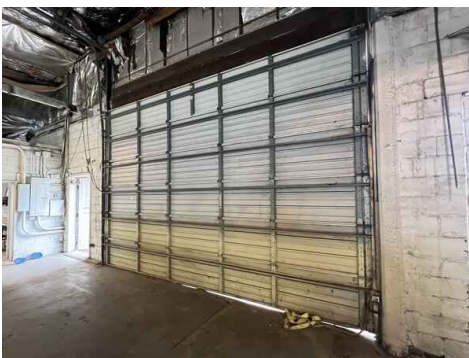
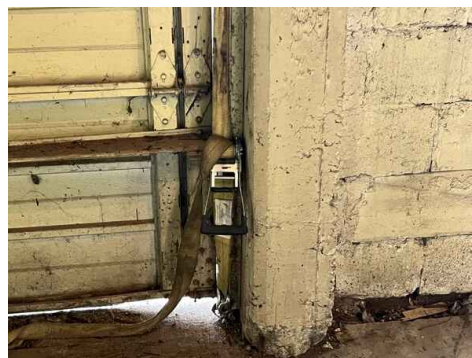
- The front garage door was secured. It was not tested.
- All tested garage doors need, at minimum, adjustment and lubrication.
- The left side garage door is severely weathered, including the wood trim and all door seals.

Front Garage Door, Secured, Not Tested

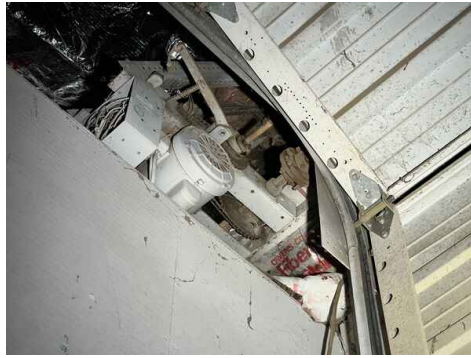
Rear Garage Door Opener, Not Connected, Operated When Tested

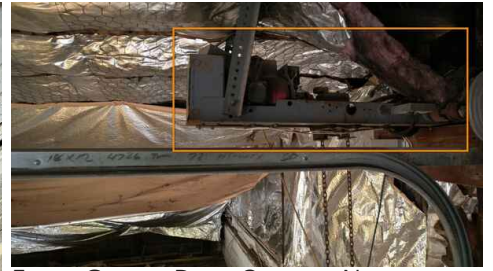
Front Garage Door Opener, Not Connected to Door, Not Tested

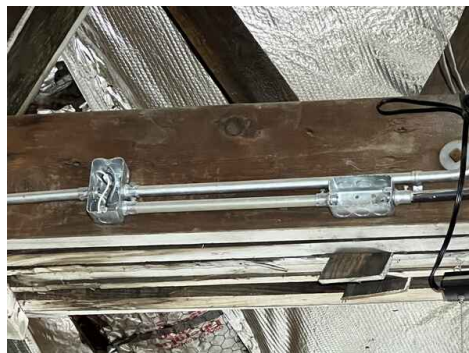
Additional Junction Boxes Missing Covers
